#### Why Tools Fail SMU: Geothermal Energy Utilization 2008

**Randy Normann, CTO**

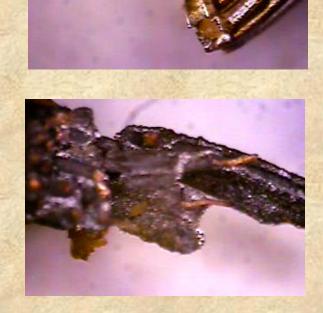
### **Copper and Tin Don't Mix**

Top image shows a clean 'cut' silver-plated copper wire rated for 250C by the manufacturer

The copper reacts with the tin (found in the solder) to form bronze crystals

This is a solid-phase interaction which leaves the wire joint fragile as can be seen in the lower photo.

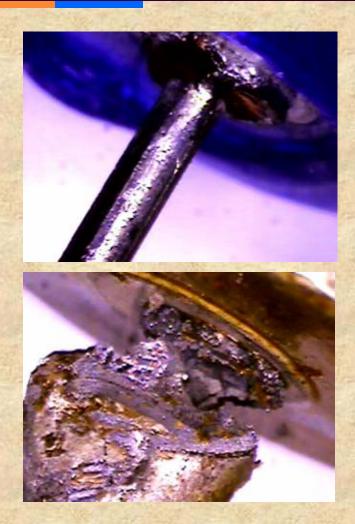
## Automotive Components Are A Gamble

The top photo is of an untested "new" capacitor lead designed for <u>automotive use</u>, 125C continuous with 200C extrusions.

The photo below is of a capacitor lead coming out of a geothermal well.

The automotive industry can sneak by with conventional solder tinned copper leads the drilling industry cannot.

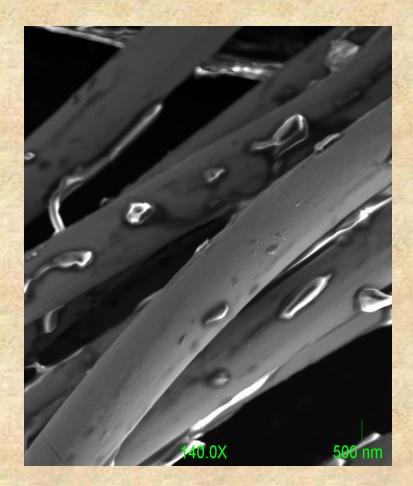
#### **Silicon Materials Transformed**

SEM image of blobs of silicone "grease or oil?" found internal to the tool. Sandia's team determined this to be the missing silicon. Extremely small amounts of well brine was entering the tool past 'metal' seals!!

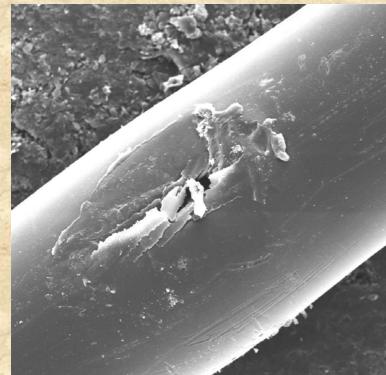
## Water Exploited Fiber Flaw

Microscopic flaws can be exploited by H2O at elevated temperatures causing the fiber to break

The fiber was examined under an SEM after exposure to steam in a lab test

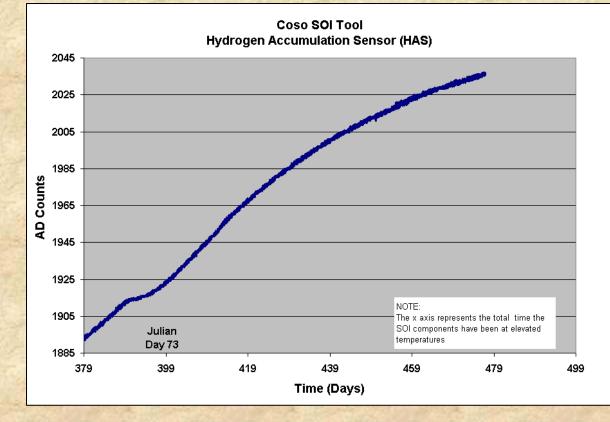
#### **Hydrogen Penetrates Steel**

Hydrogen sensor inside the tool measures hydrogen entering the tool. Free hydrogen is created as brine interacts with well casing

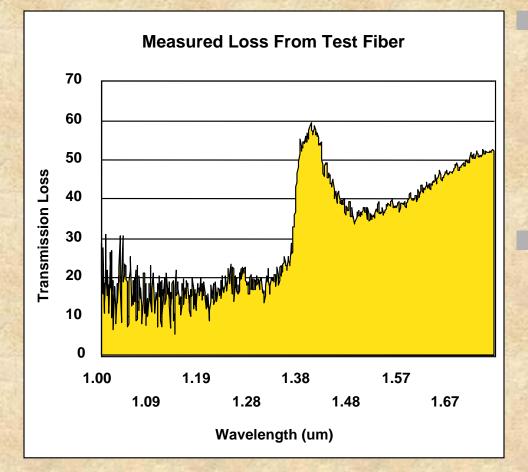
# **Fiber Optics: Nothing but Glass?**

Light loss in a 50ft section of 300C fiber after 1 year in a 180C well!!

Hydrogen from the well bonds in the fiber creating OH and massive light loss
