## **A study aimed at characterizing the interfacial structure in a tin–silver solder on nickel-coated copper plate during aging**

**Abstract.** This paper highlights the interfacial structure of tin-silver (Sn-3.5Ag) solder on nickel-coated copper pads during aging performance studies at a temperature of 150°C for up to 96 h. Experimental results revealed the as-solidified solder bump made from using the lead-free solder (Sn-3.5Ag) exhibited or showed a thin layer of the tin–nickel–copper intermetallic compound (IMC) at the solder/substrate interface. This includes a sub-layer having a planar structure immediately adjacent to the Ni-coating and a blocky structure on the inside of the solder. Aging performance studies revealed the thickness of both the IMC layer and the sub-layer, having a planar structure, to increase with an increase in aging time. The observed increase was essentially non-linear. Fine microscopic cracks were observed to occur at the interfaces of the planar sub-layer and the block sub-layer.

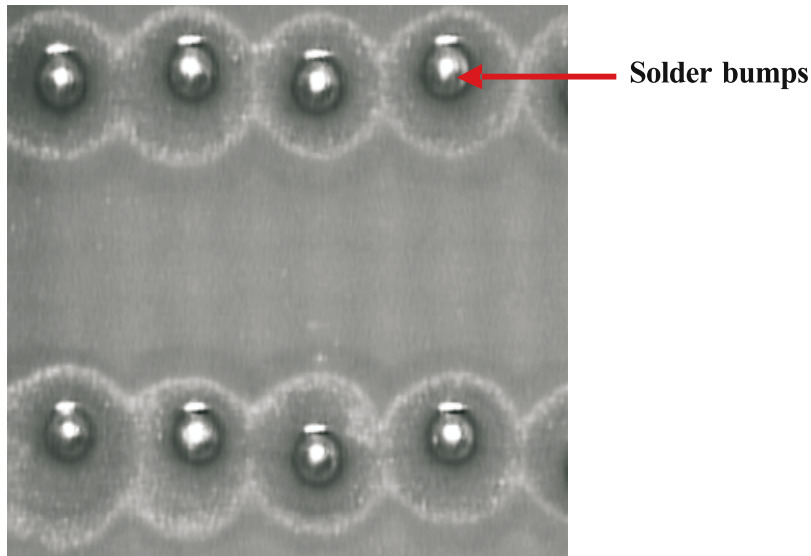
**Figure 1.** An overhead view of the solder bumps on a printed-circuit (PC) board.

(f) The as-solidified solder bump is shown in figure 1.

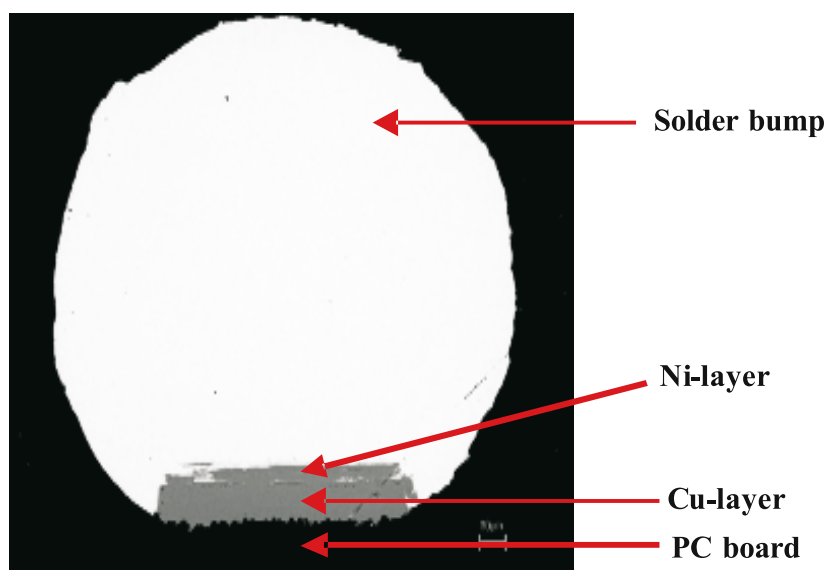
**Figure 2.** Cross-section view of a single solder bump.

A typical cross section of an as-solidified solder bump is shown in figure 2. The magnified details at the interface between the solder and substrate of the nickel-coated copper pads are shown in figure 3. In figure 3a backscattered electron micrograph is shown, taken at the solder/substrate interface. Figure 3b reveals the distribution of key elements in the nickel-layer through EDS analysis using the point mode technique. Figure 3c reveals the key elements in the copper-layer while figure 3d is an EDS of the Sn–Cu–Ni compound. The distribution of key elements was obtained using the attached X-ray detector with analysis made possible using the EDAX software. The elements present in the various layers are summarised in table 1.

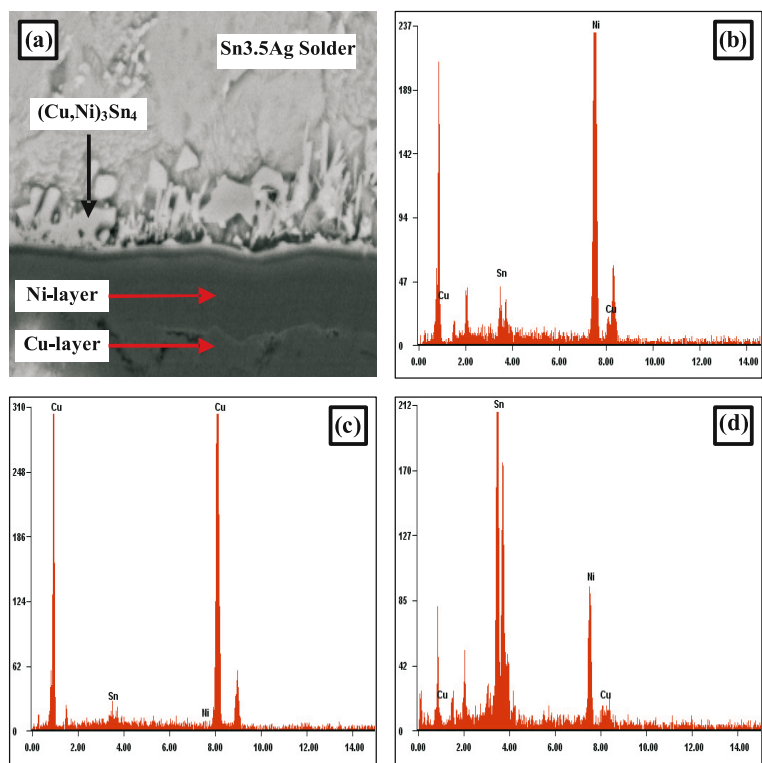
**Figure 3.** Backscattered SEM image and EDS analysis for the Sn3.5Ag solder bump. **(a)** Interfacial structure, **(b)** EDS map of the nickel layer, **(c)** EDS map of the copper layer, **(d)** EDS map of the Sn–Ni–Cu compounds.

From both figure 3 and table 1, it is observed that the composition of the Ni-layer shows a distribution of 91.08% Ni, 4.17% Sn and 4.75% Cu. Further, in this layer, both tin and copper are believed to come from the neighbouring solder and the copper-layer. In the copper-layer, the EDS analysis shown in figure 3c reveals a distribution of 96.07% Cu, 1.24% Ni, and 2.69% Sn. Further, in this layer the nickel and tin are believed to come from the neighbouring nickel layer and the solder by way of diffusion. On the solder side, i.e. near the solder/substrate interface, EDS analysis revealed (figure 3d) a distribution of 60.86% Sn, 33.72% Ni, and 5.42% Cu. This indicates the presence of the Sn–Ni–Cu ternary phase at the interface. This was identified to be the  $(\text{Ni}_x\text{Cu}_y)_3\text{Sn}_4$  in the published literature (Kang *et al* 2002).

The morphology at the interface shown in figure 3a is not characterized by the presence of scallop-like Sn–Cu intermetallic compounds (Chuang *et al* 2004). It includes two sub-layers: (i) A planar looking Sn–Ni–Cu sub-layer, which is adjacent to the nickel layer. (ii) A blocky looking Sn–Ni–Cu sub-layer, which is immediately adjacent to the solder.

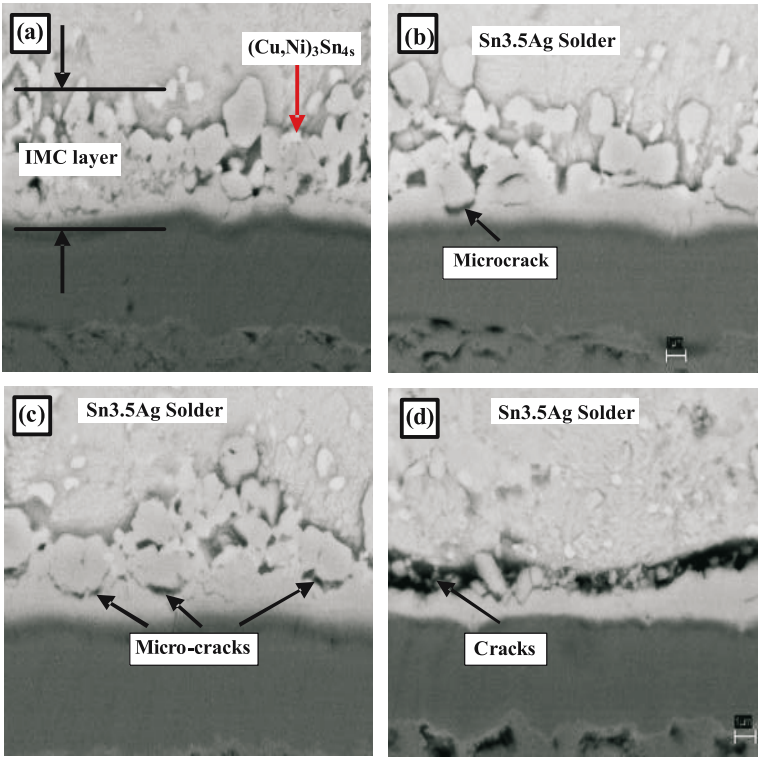
**Figure 4.** Backscattered scanning electron micrographs showing the interfacial structure when subjected to various aging times: (a) 24 h, (b) 48 h, (c) 72 h and (d) 96 h.

The microstructure of the Sn3·5Ag solder bumps on subjecting to a thermal aging treatment at 150°C is shown in figure 4. The interfacial structure following 24 h treatment is as shown in figure 4a. To quantify the influence of aging time on microstructure, the thickness of the IMC is measured using the definition shown in figure 3a. The thickness of the IMC was 4 microns ( $\mu\text{m}$ ) following exposure to the temperature for 24 h and is shown in figure 4a. The thickness of the IMC was 2·8 microns ( $\mu\text{m}$ ) for the as-solidified case and is shown in figure 3a. Results using the same measurement technique for the other coupons that were aged for 48 h (figure 4b); for 72 h (figure 4c), and for 96 h (figure 4d) are summarised in table 2. The variation of thickness of the IMC as a function of aging time is shown in figure 5. It is observed that the thickness of the IMC increases with an increase in aging time at temperature. Further, it was observed that the highest increase in the thickness of the IMC occurred during the first day or 24 h of aging at the chosen temperature. Following the initial increase there occurs a reduced rate of increase in the thickness of the IMC. After a certain time interval of exposure, the thickness of the IMC cannot increase any further since both microscopic cracks (figure 6a) and macroscopic cracks (figure 6b) appear at the solder/substrate interface.

Further, it is seen from figure 4 that the microscopic cracks in the samples that occurred in a region between the planar Sn–Ni–Cu sub-layer and blocky-like non-planar sub-layer of Sn–Ni–Cu, in particular at the root of the blocky sub-layer (see figure 6). The overall thickness of the planar Sn–Ni–Cu sub-layer, measured from figure 3a, figure 4a, figure 4b, figure 4c, and figure 4d, increases with an increase in aging time as summarised in table 3 and shown in figure 7. It was found that the thickness of the planar sub-layer and the whole or entire IMC layer, as a function of aging time at temperature of 150°C, increases with time of exposure to temperature. The macroscopic cracks occurred upon exposing the solder bumps to the high temperature environment 150°C for 96 h aging and are conveniently located along the boundary line, which separates the planar-like and the blocky-like Sn–Ni–Cu intermetallic compound.

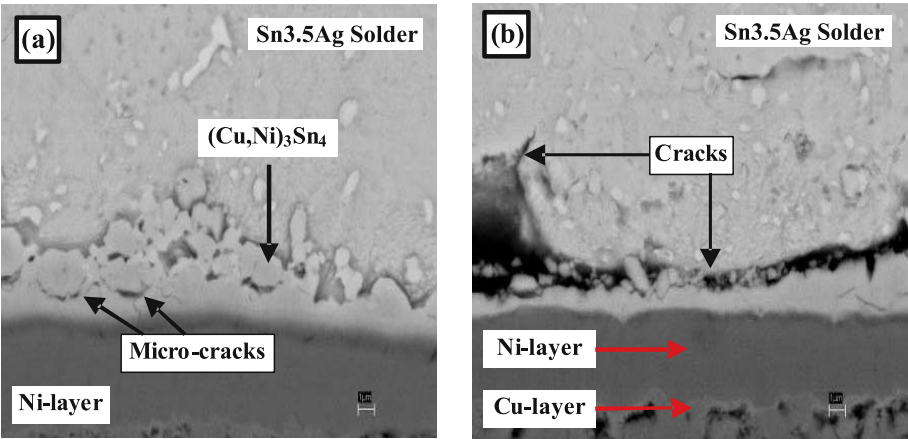
**Figure 6.** Scanning electron micrographs identifying the presence and location of the: (a) microscopic cracks, and (b) macroscopic crack.

The presence of fine microscopic cracks along the grain boundaries is caused by a gradual accumulation of stress and resultant strain during aging at the higher temperature. Further, a noticeable difference in the thermal expansion coefficient of the various layers, i.e. copper, nickel and solder causes the microstructure of the Sn–Ag solder that was subjected to aging

at 150°C for 96 h reveals a transformation of the microscopic cracks to macroscopic cracks to occur along the boundary line of the blocky-like compounds and the planar-like looking compounds.
